Manhole Inspection Summary

Manhole # S45II_021MH

Insp Date: **4/29/08 8:48 AM**

Location Address: **Oliver St**

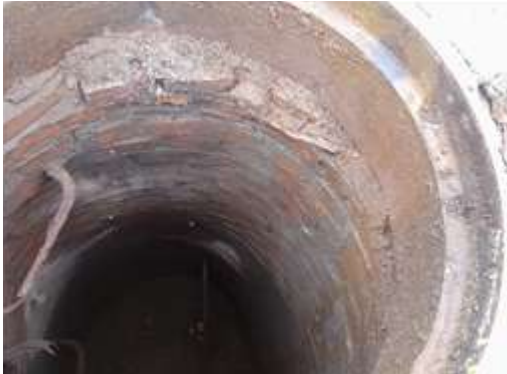
Defect 2

Deterioration

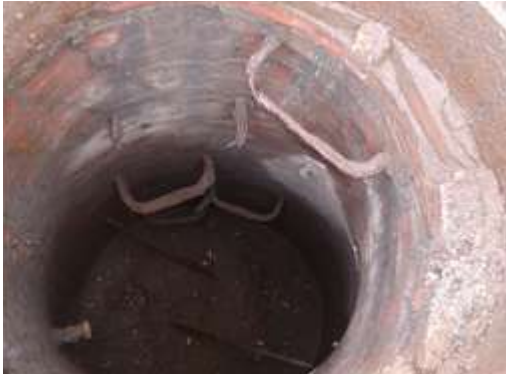
Defect 1

Condition: ☐ Sound ☐ Cracked ☐ Root Intrusion ☒ **Loose Brick** ☐ Deteriorated

Infiltration: ☐ None ☐ Joint ☐ Cracks ☒ **Mortar** ☐ Roots ☐ Wall

Loose Bricks

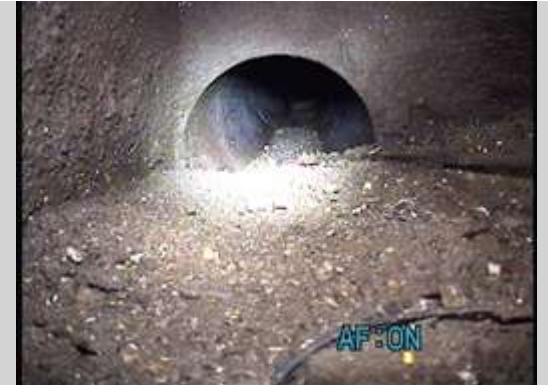
12 O'Clock Outflow

8 in. Circular Gravity Sewer
Pipe Out @ 12 O'Clock

Deposits: ☐ None ☐ Mud ☐ Sludge ☒ **Debris** ☐ Grease

Silt Depth: **4** (in.) Deposits Extent: **Medium**
